# JOURNAL OF THE GENERAL UNION OF ARAB ARCHAEOLOGISTS

**Special Issue on Conservation and Restoration**

**Volume 11/3**

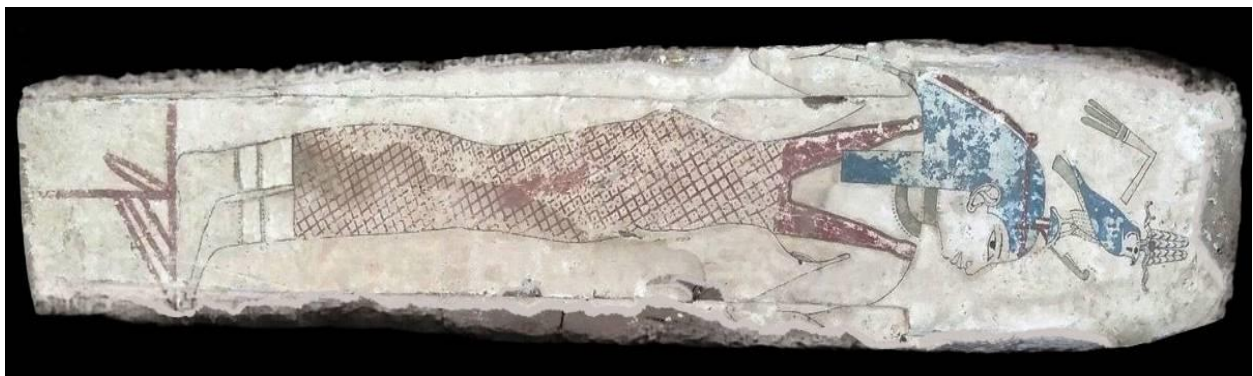
[FIGURE 17] The painted wooden coffin base after treatments © Photo taken by the researcher

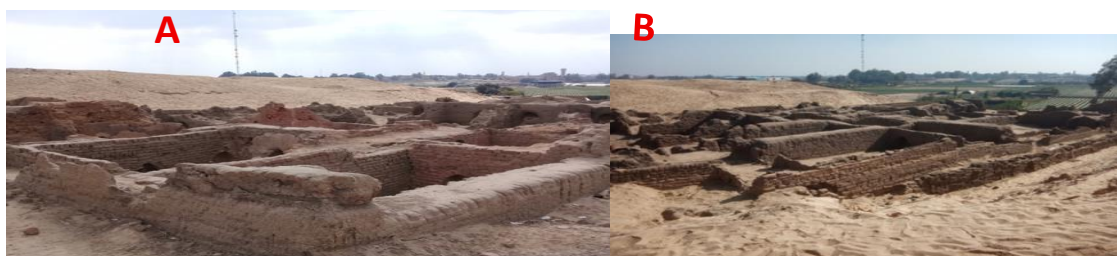
[FIGURES 1/A-B]: The Quesna archaeological cemetery, with evident adobe architecture patterns © Photos taken by BASSEM MANSOUR

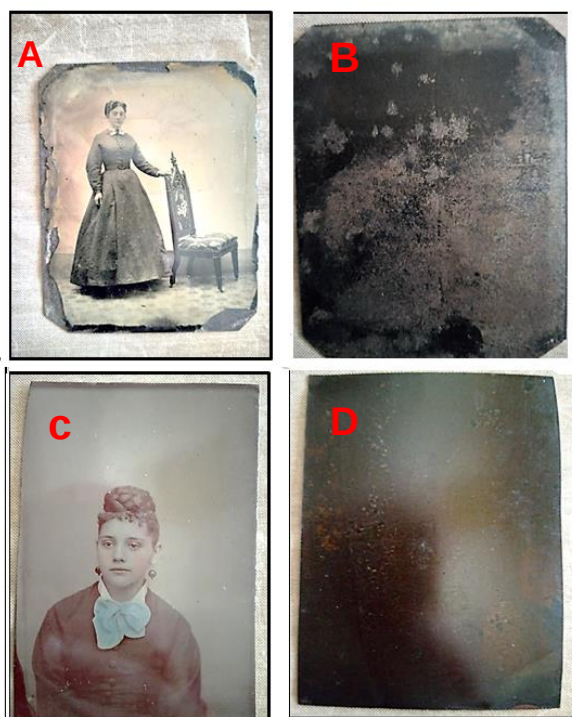
[FIGURES 2/A-D]: Shows the current condition of the photographs under examination. A-B. The monochrome tintype; C-D. The hand-colored tintype, presented in recto and verso views, exhibiting various forms of deterioration © Done by the researchers

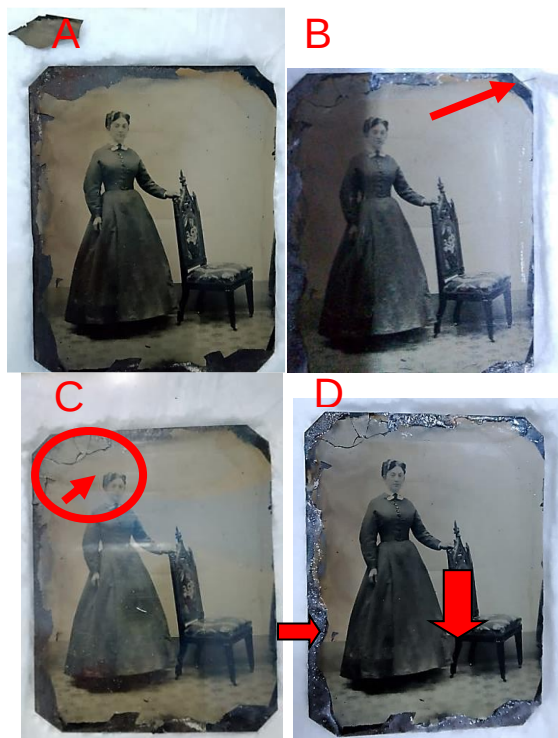
[FIGURES 18/A-B]: Consolidation of the monochrome tintype and the restoration of losses. A. Detached parts. B. Consolidation of fragile parts. C. Fixing of the detached parts. D. Compensating for losses ©  
Done by the researchers

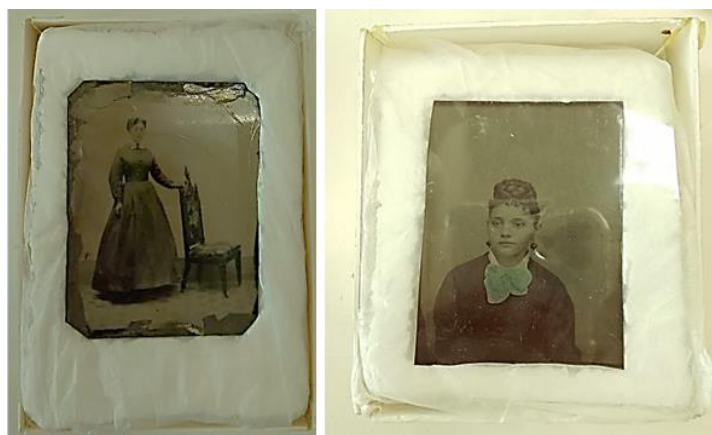
[FIGURE 21]: Housing of the monochrome and the hand-colored tintypes © Photo taken by HADEER M. ELDEEB

Dealing with photographs in general, particularly monochrome or hand-colored tintype images, requires exceptional care due to their complex multilayered structure, the inherent sensitivity of their materials and their rarity. Therefore, strict precautionary measures must be followed to ensure their protection and preservation<sup>40</sup>. The hands must be clean and cotton gloves must be worn, as the oils and fats from skin contact can cause irreversible damage. Special attention must be given to the quality of handling and storage materials. All storage components should be acid-free, since acidic environments can promote yellowing and rusting of the metal support<sup>41</sup>, particularly in the presence of high relative humidity. Accordingly, it was necessary to prepare proper housing for the photographs to safeguard the tintypes from dust, airborne pollutants and physical damage. Two custom-made boxes were constructed using acid-free cardboard and acid-free compressed foam, which was precisely emptied from the inside to match the dimensions of the studied photographs. A layer of Japanese paper was placed as a separator between the image and the foam. The images were then covered with a sheet of polyester [FIGURE 21].

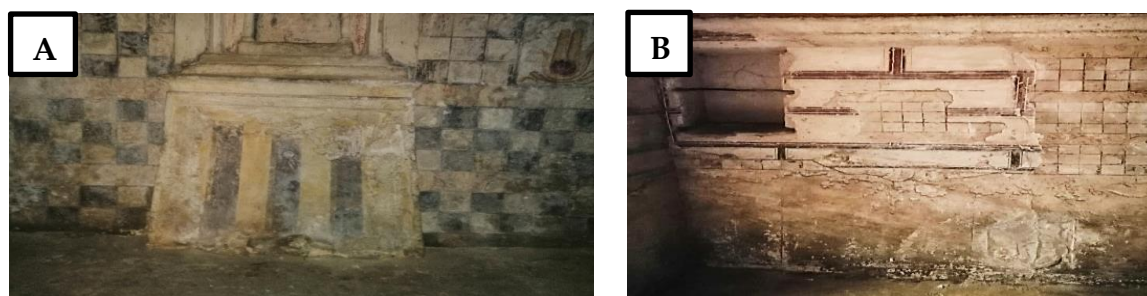
[FIGURES 3/A-B]: Areas for sample collection; A. Fading pigments and salt efflorescence on the surface; B. Broken film layers with a growing fungus in the regions near the ground © Photos taken by MOHAMED ABD ELRAHIM

Initial findings indicated the presence of multilayered paintings «overpainting» [FIGURE 2/B] & [FIGURE 3/B] featuring lustrous surface layers, accompanied by extensive salt formation and efflorescence [FIGURE 3/A].

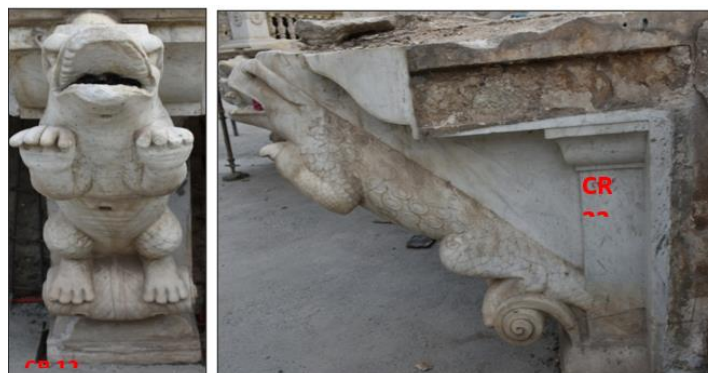
[FIGURE 3]: The impact of common external factors including wind, heat and pollution on the marble statues, resulting in color darkening, the appearance of stains, the formation of cracks and progressive disintegration ©Photo taken by MOHAMED ABDAL AZYZ

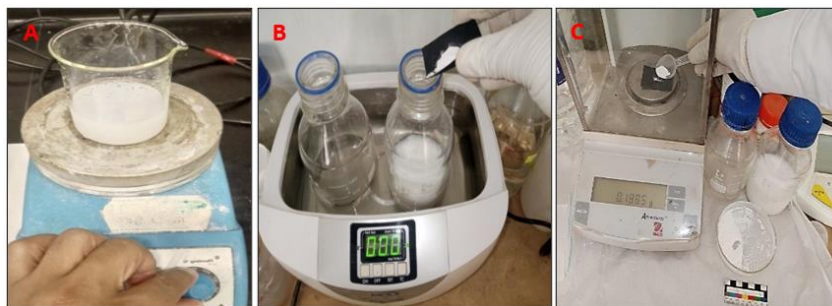
[FIGURES 5/A-C]: Different stages of preparation of the nanocomposites used in the study © Photo taken by the authors

carried out for 30 minutes to ensure complete dispersion and uniform distribution of the nano-enhancer within the polymer matrix [FIGURES 5/A-C].

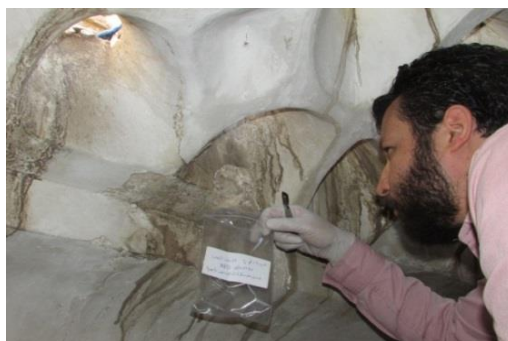
[FIGURE 10]: Shows taking 1A, 4D samples from bathroom ceiling stucco dome © Photo taken by MOHAMED ATYIA HAWASH

X-ray diffraction «XRD» analysis was conducted using a second-generation D2 PHASER powder diffractometer «Bruker Corporation, Germany» to determine the mineralogical composition of samples collected from the stucco domes of the bathroom ceiling. Two samples were analyzed: the first (4D) was taken from the upper surface of the dome and represents the old, damaged glass-setting mortar, while the second (1A) was collected from the interior of the dome and corresponds to the stucco mortar forming the domes.

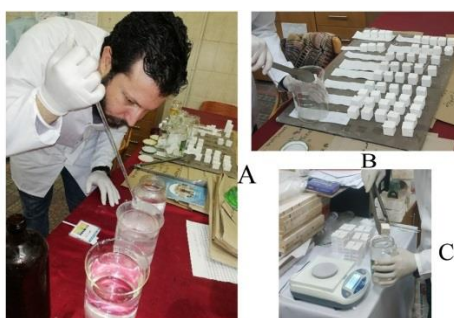
[FIGURES 14/A- C]: A. Shows Preparing an acidic sulfuric acid solution; B. Soaking samples in the acidic solution; C. Weighing samples before and after soaking in the acidic solution © Photo taken by

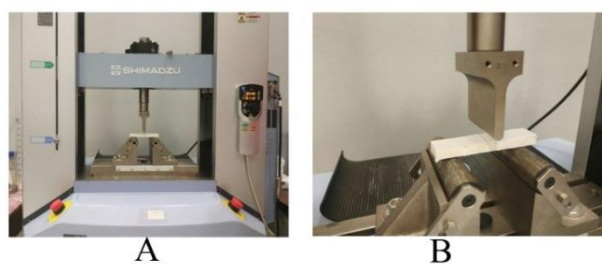
[FIGURES 15/A-B]: Shows Mechanical testing apparatus and three-point bending test method © Photo taken by OSAMA SAMIR

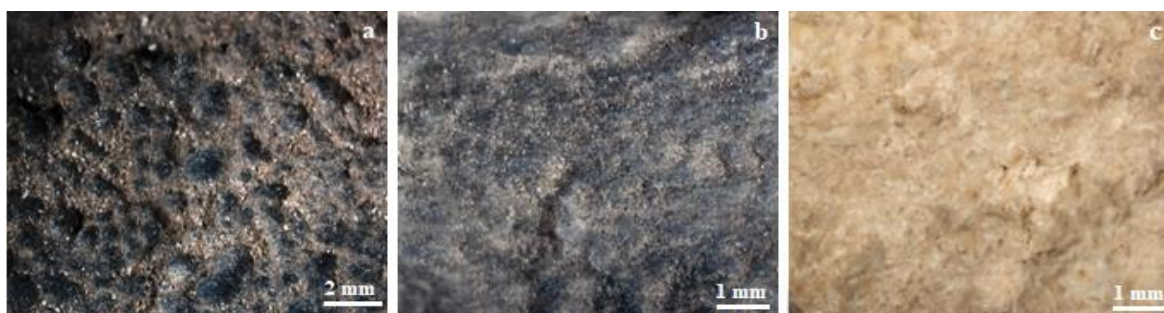
[FIGURES 5/A-C]: Stereo micrographs of a limestone [Sample N<sup>o</sup>.2]; A. Before treatment; B. After chemical pre-treatment; C. After biological treatment © Done by the researchers

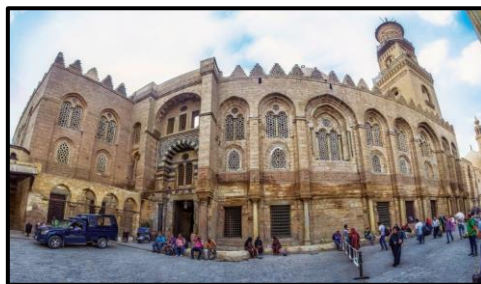
[FIGURE 14]: The Sultan Qalawun Complex with its façades affected by black crust, <https://www.cairo.gov.eg/ar/pages/CairoInLines.aspx?CiLID=6>, accessed on (01/11/2025)

The combined chemical–biological cleaning method was applied to a blackened wall surface at the Sultan Qalawun Complex [FIGURE 14]. A non-ionic detergent poultice (Tween 80) was first applied for 6 hours. It effectively softened and loosened superficial deposits that were less tightly attached to the surface. Then, biological treatment was carried out for 22 hours until the black crust was completely removed. Combining both treatments enabled the quick removal of the black crust, restoring the stone's original appearance after just three biological applications [FIGURES 15-16].

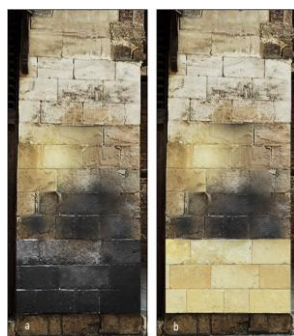
[FIGURES 15/A-B]: A. Shows the blackened wall before treatment; (B). The cleaned area after chemical–biological treatment © Photo taken by the researchers

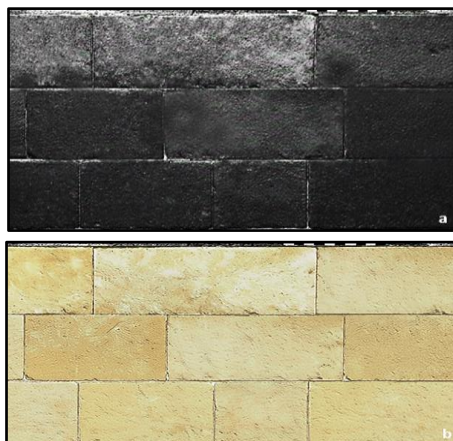
[FIGURES 16/A-B]: A. Shows the blackened limestone surface before treatment; B. The surface after chemical–biological treatment © Photo taken by the researchers

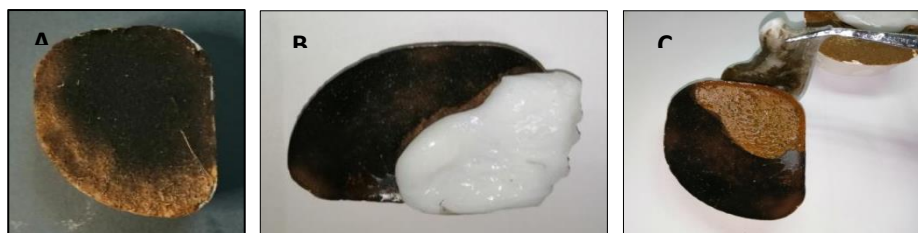
[FIGURES 1/A-C]: Visual examination before, during and after the application process, which ranged between 2-3 mins. The hydrogel was removed by forceps as a cohesive unit. The cleaning efficacy of the soot stain with no residues observed on the surface © Done by the authors

until the desired final concentration was reached<sup>21</sup>. A cleaning test was performed on a mock-up sample by applying the hydrogel slab to soot. The results were evaluated using a visual examination to assess the efficiency of the PVA hydrogel nanocomposite. It was observed that the time of removal ranged between 2-3 mins, then the slab was cautiously peeled off using a forceps in a cohesive state with no hydrogel residues observed on the surface [FIGURES 1/A-C].

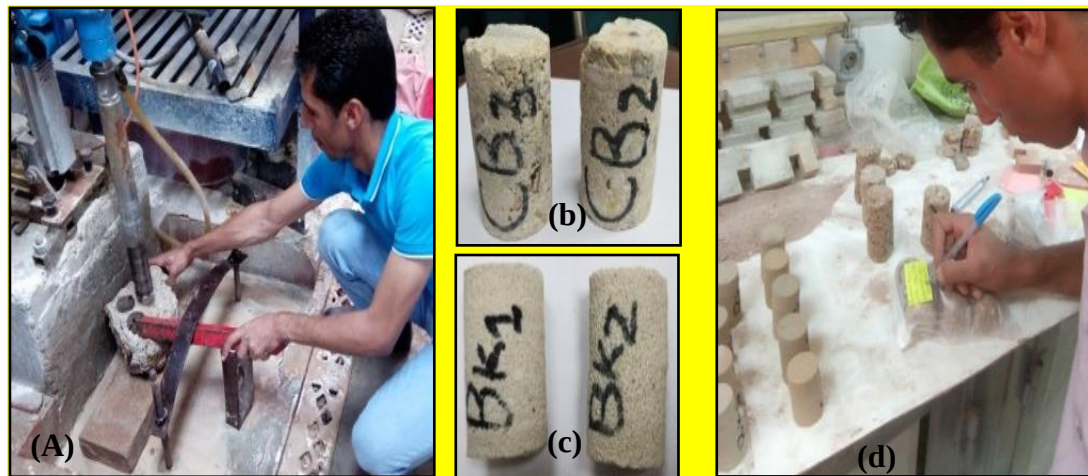
[FIGURES 1/A-D]: Preparation and coding of the building materials specimens and samples under investigation © Done by the authors.

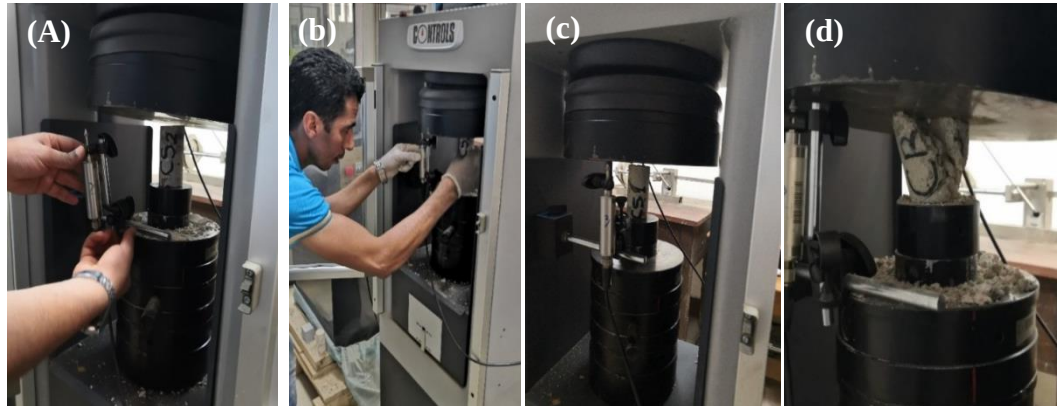
[FIGURES 2/A-D]: Uniaxial compression test setup for reinforced concrete, bricks and steel rebar  
© Done by the authors

The compressive strength ( $\sigma_c$ ), tensile strength ( $\sigma_t$ ), and flexural strength ( $\sigma_f$ ) were evaluated in accordance with (CEN, 2006), EN 1015-11:1999, on a total of six concrete cylinders, five lime cement bricks, and four steel specimens of various sizes. The specimens were subjected to loading using steel plates measuring 40 × 40 mm<sup>2</sup>. The results are compiled in the following [TABLES 1-7]. The strength measured from each specimen, along with average values and corresponding coefficients of variation (CV), are represented in the following tables and figures. [FIGURES 1/A-D] represent the preparation and coding of the building materials specimens under investigations. [FIGURES 2/A-D] represent the uniaxial compression test setup for the reinforced concrete.

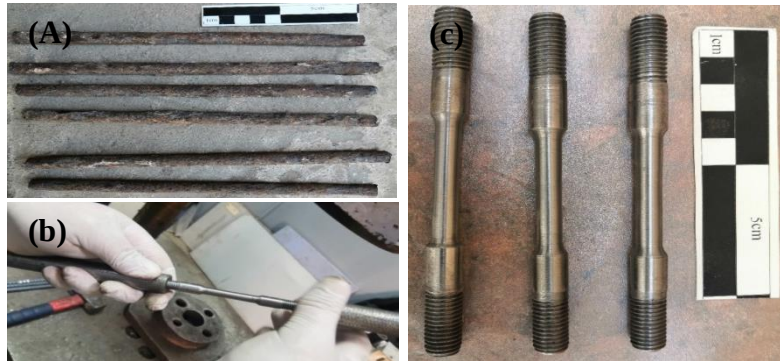
[FIGURES 3/A-C]: Preparing steel rebar samples in preparation for the tension test  
© Done by the authors

Tension test was performed on three different steel samples of palace «slabs and beams» after processing these samples as in [FIGURES 3-4] to comply with the test device.

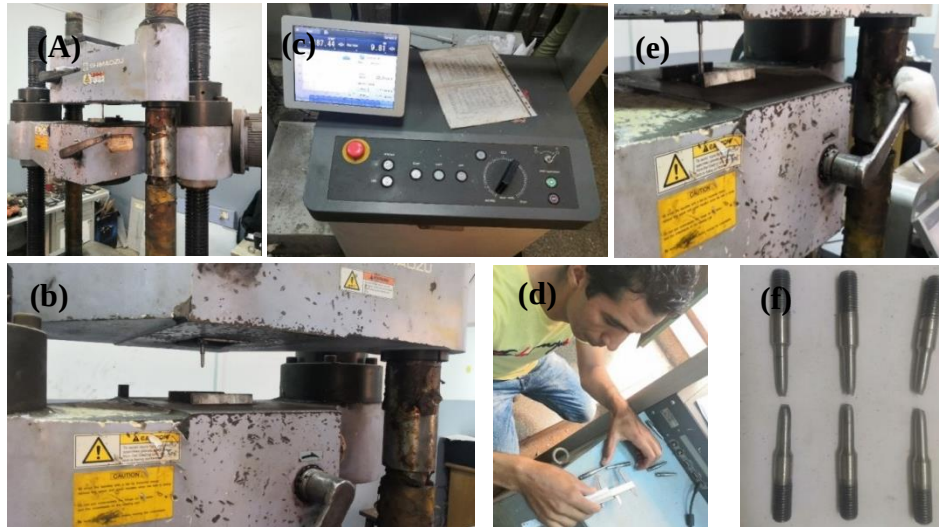
[FIGURES 4/A-F]: Setting steel rebar samples in the test device and conducting the tension test  
© Done by the authors

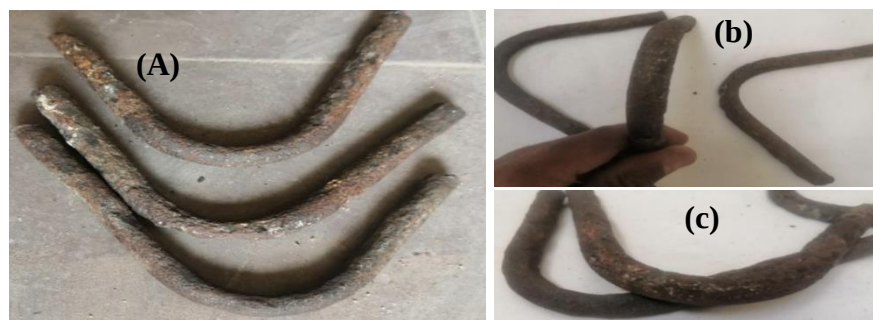
[FIGURES 9/A-C]: The results of the bending test, which showed good resistance to the bending strength and the absence of cracks. © Done by the authors

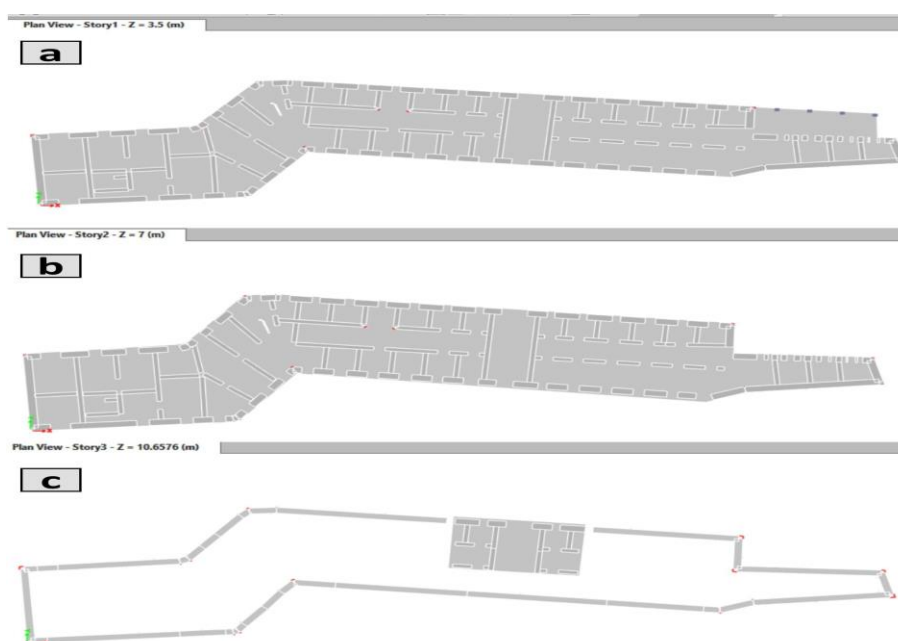
[FIGURES 2/A-C]: 2D plans views for A. First story, B. Second story and C. Third story of Ṭābiyat 'Urābī © Done by the authors

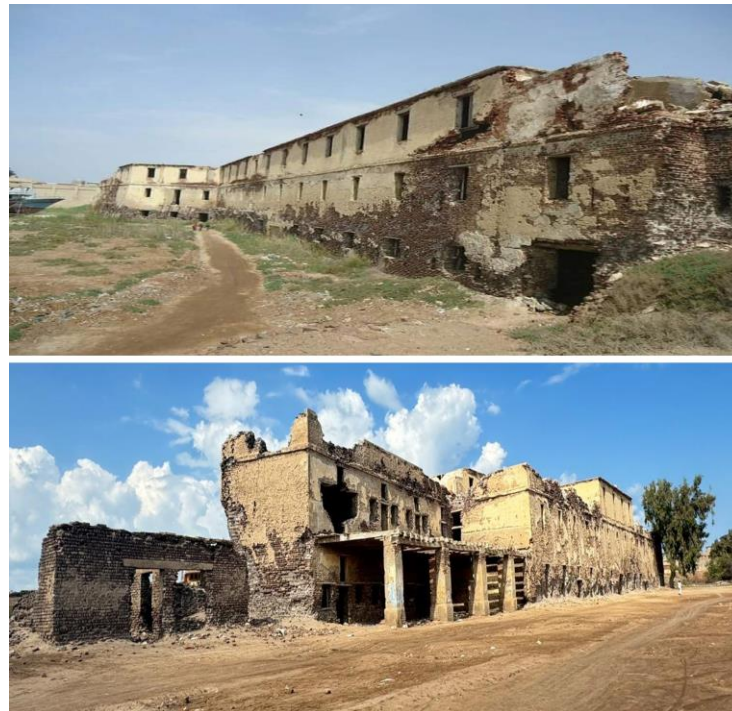
[FIGURE 4]: The structural system of Ṭābiyat 'Urābī with the in-plane and out-of-plane deformation patterns © Done by the authors

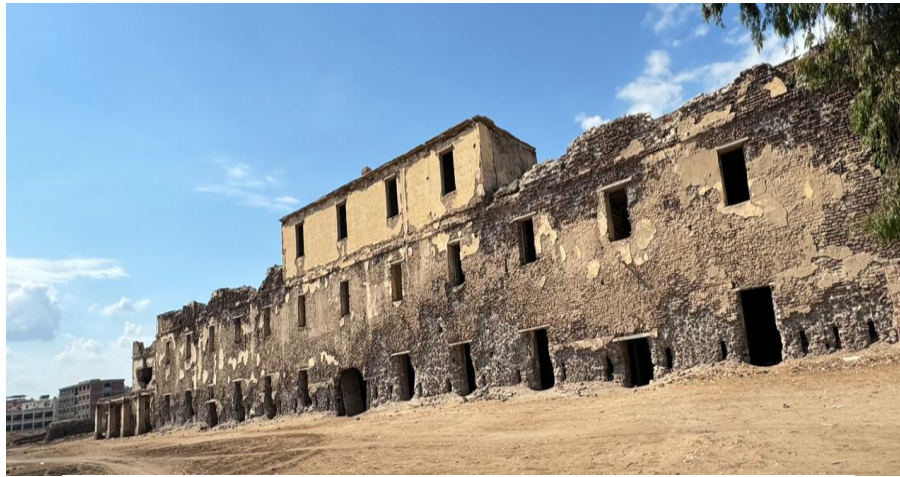
[FIGURE 12]: Critical points and stress contours indicating compression/tension distribution © Done by the authors

- The ETABS shell force output was reprocessed to ensure correct conversion from force per unit length (kN/m) to stress (kPa) using the relation  $\text{stress} = (\text{force\_per\_length}) / \text{thickness}$ . The units should be verified carefully and the values should be cross-checked with the direct element reaction outputs.
- Perform localized material shear tests and diagonal compression/shear tests in the laboratory to determine the true shear capacity of the masonry. [FIGURE 12] shows the critical points and stress contours indicating the compression/tension distribution.

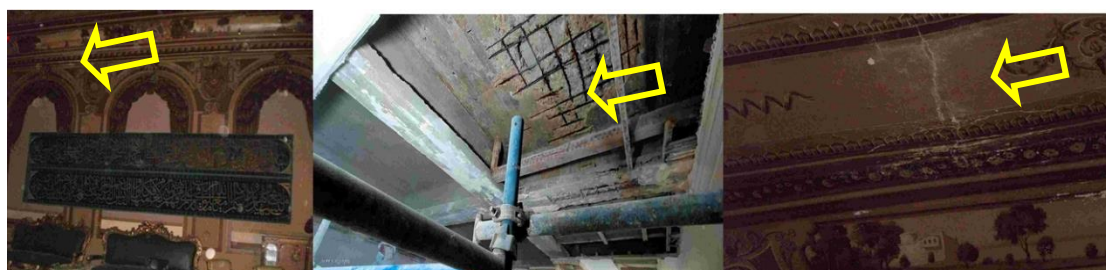
[FIGURE 6]: Structural deterioration in the walls and ceiling of the *Kiswa Hall*, showing the location and extent of cracks marked by the arrows © Photos taken by TAHA ATALLAH

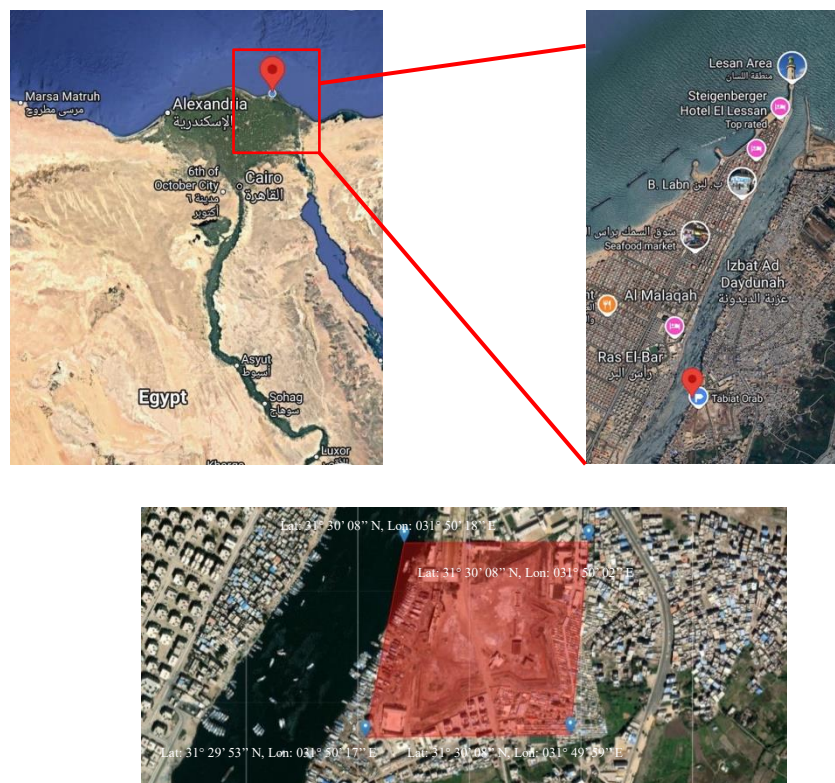
[FIGURE 2]: Shows the location of *Ṭābiyat 'Urābī* after downloading and analyzing satellite images using the remote sensing program; it demonstrates downloading satellite images from the USGS website to use the ENVI remote sensing program to analyze thermal satellite © Done by the authors

Satellite images were downloaded from the USGS website. Accordingly, thermal satellite images were analyzed to extract temperatures using the ENVI remote sensing software by applying a set of equations to the thermal range of the image to extract temperatures of *Ṭābiyat 'Urābī* in the northern part of Damietta Governorate on the edge of the Mediterranean [FIGURE 2].

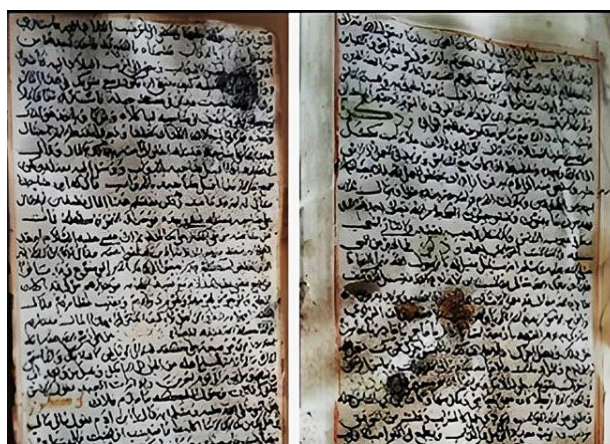
[FIGURE 1]: The historical sample © Photo taken by AHMED HOSNI

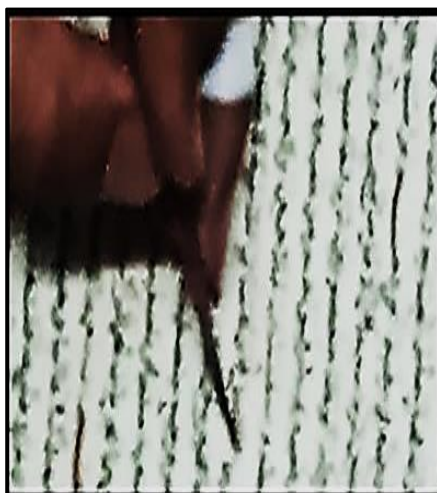
[FIGURE 3]: Experimental sample with the same type of ink © photo taken by AHMED HOSNI

The manuscript is in the Manuscript Center at Minia University<sup>12</sup>. It suffers from the corrosion of the iron ink, acidity, yellowing of the paper, dirt, stains, wrinkles and some tears<sup>13</sup>. Fourier Transform Infrared Spectroscopy (FTIR) was used to determine the type and ink of the manuscript<sup>14</sup>. First, a small sample of iron ink was taken from an inconspicuous place. It was done in the Infrared Laboratory, Research and Conservation Center, Projects Sector, Antiquities Research and Conservation Center using the Nicolet Nexus 750 device, which monitors spectra between 4000–550 cm<sup>-1</sup> with a spectral resolution of 4 cm<sup>-1</sup> and recording the spectra using the program OMNIC software (version 6.0)<sup>15</sup> [FIGURE 2]. The experimental sample was made with the same type of ink [FIGURE 3].

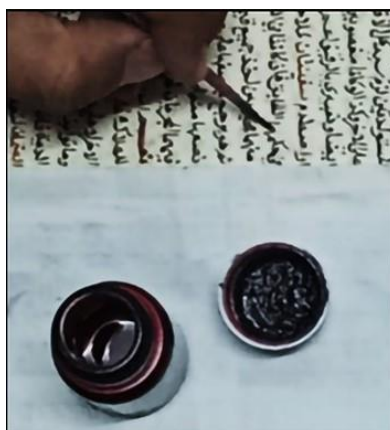
Nanomagnetite was applied to the experimental sample with a brush under magnification to coat the letters suffering from corrosion and to preserve the non-corroded letters [FIGURE 6].

[FIGURE 6]: Applying the nanomaterial to the experimental sample © Photo taken by AHMED HOSNI

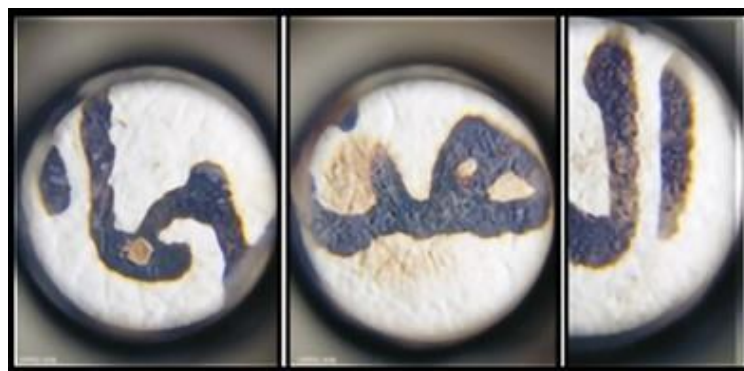
The visual evaluation shows the iron ink before and after the nano application and the detection of photochemical changes using the 60x 60x smartphone microscope, as well as the two [FIGURES 7-8].

[FIGURE 7]: Iron ink corrosion observed using a smartphone microscope (OPPO 16), showing brown spots, paper staining and ink fading © Photo taken by AHMED HOSNI

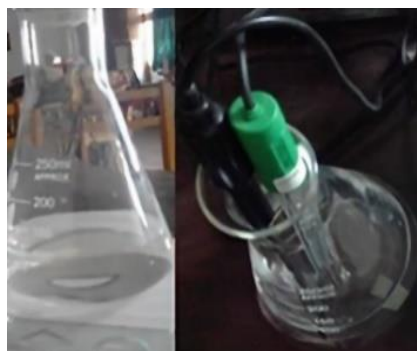
[FIGURE 9]: Acidity measurement © Done by the authors

balance and preventing further deterioration. This also enhances the strength of weak and fragile manuscripts<sup>36</sup> [FIGURES 9-10]
